HETA 95-0200-2579
Jim Dixon Lincoln-Mercury, Inc.
Fairfield, Ohio

Health Hazard Evaluation Report 95-0200-2579
Jim Dixon Lincoln-Mercury, Inc.
Fairfield, Ohio
May 1996

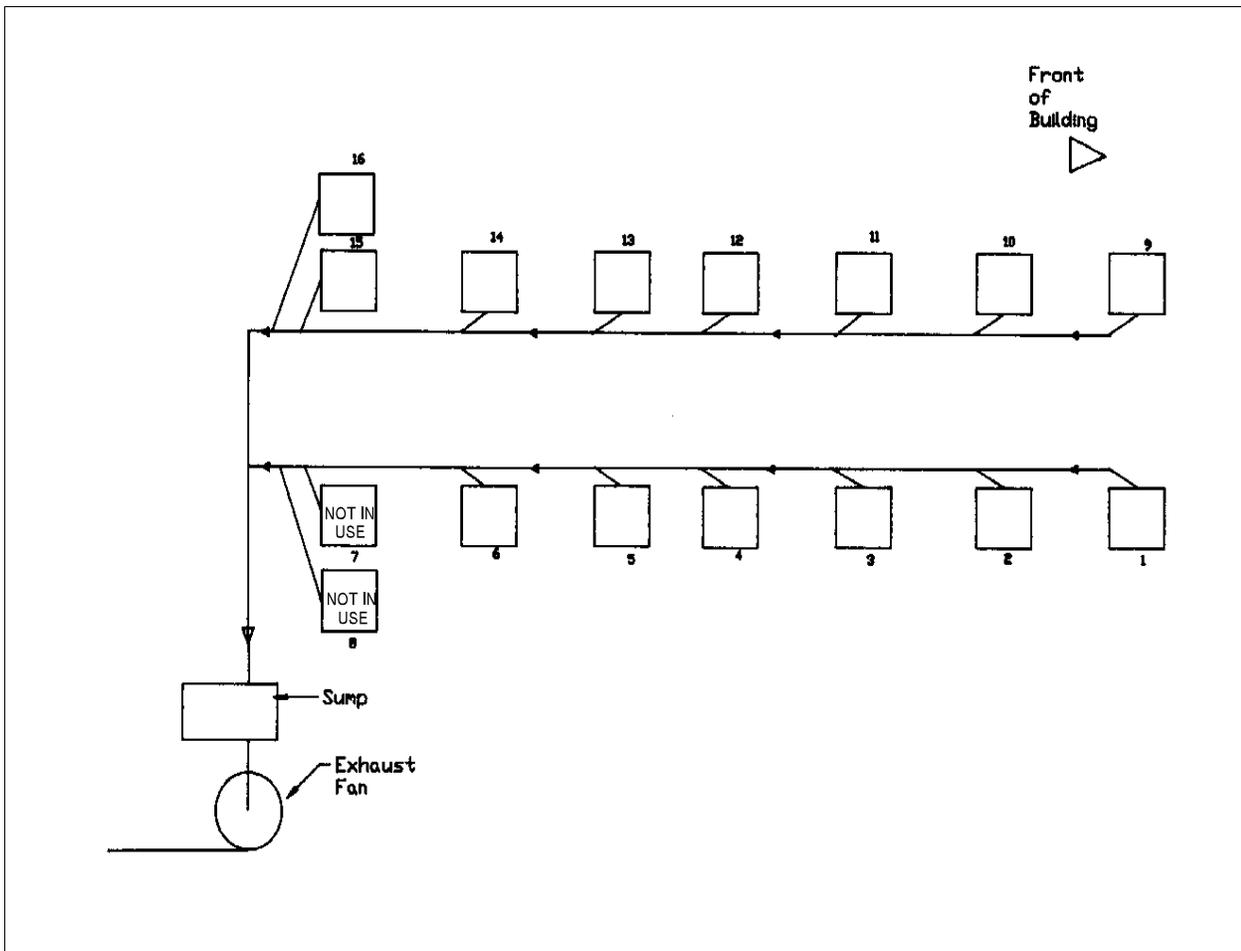
Figure 1
Line Diagram of Carbon Monoxide Removal System
Jim Dixon Lincoln-Mercury, Inc.
Fairfield, Ohio
HETA 95-0200

As shown in the line diagram of Figure 1, there were 16 steel-framed engine exhaust ports in the garage floor. Two (#7 and #8) were bolted closed. The remaining 14 exhaust ports, 1 at each service bay area of the garage, direct vehicle tail-pipe exhaust gases from a flexible exhaust hose into a common duct under the service area garage floor. Tail-pipe exhaust gases pass through the under-floor duct to a sump, where any liquids in the ventilation system are trapped and pumped to waste. The exhaust gases are then directed out the side of the building through an exhaust fan. Hinged steel cover plates, flush to the garage floor, cap the individual exhaust ports when they are not in use.

1. The exhaust port covers should be replaced with covers having self-closing caps. The exhaust port covers and caps should provide an airtight seal when not in use.

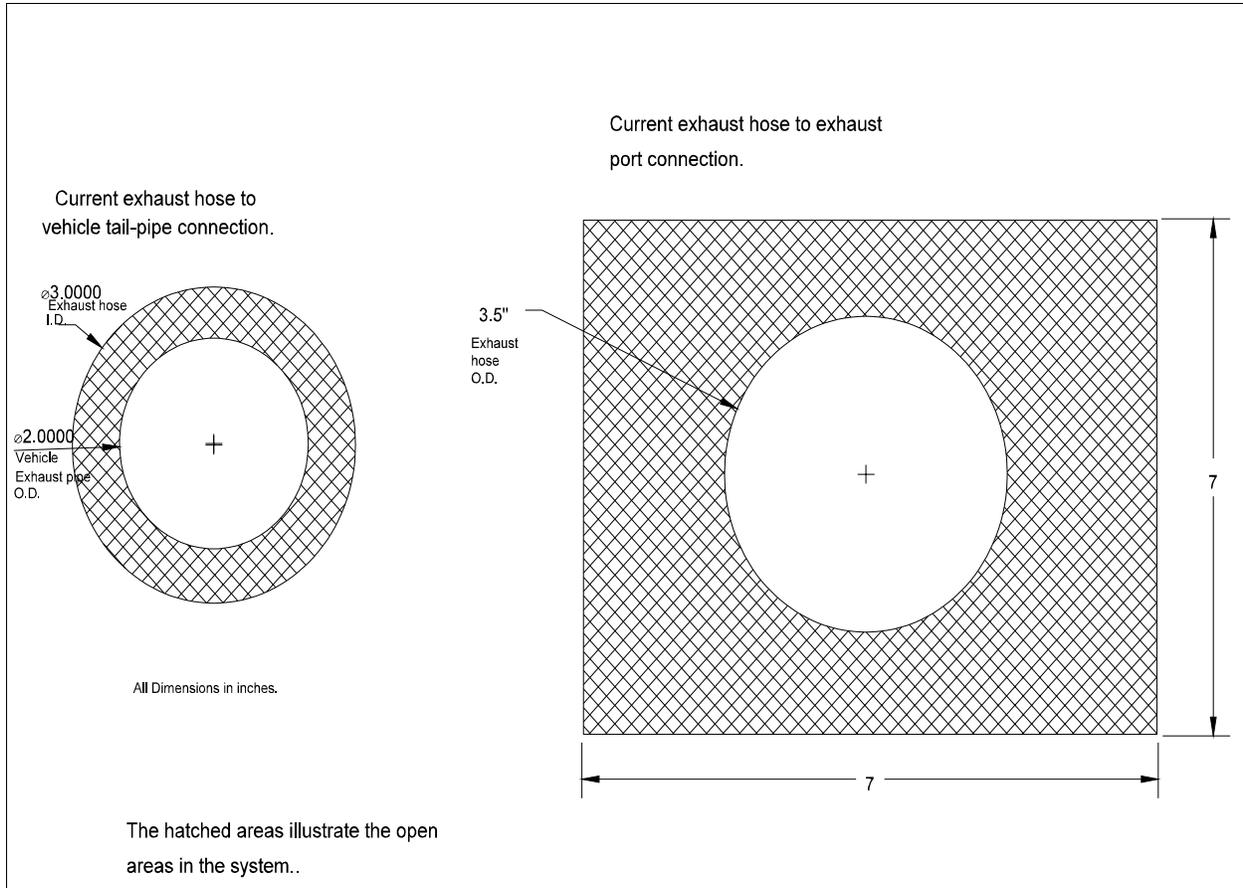
Figure 2
Existing Flexible Garage Exhaust Hose to Tailpipe and Export Port Leak Areas
Jim Dixon Lincoln-Mercury, Inc.
Fairfield, Ohio
HETA 95-0200

Three and one half-inch (in) outside diameter flexible garage exhaust hoses vary in length from six to ten feet. One end of the flexible hose fits over the vehicle's tail pipe (an average tail-pipe diameter is about 2 in). The other end of the flexible hose is placed into the 7 in square exhaust port. When a flexible hose is connected between a vehicle tail-pipe and exhaust port, approximately 4 square inches (in²) of leakage area exist between the tail pipe and the flexible hose. Forty in² of leakage area exist between the exhaust port and flexible hose (see Figure 2). In addition, a total of 12 in² of leakage area exists through two 3/4-in diameter finger holes, in each of the 14 functional cover plates. The finger holes provide access to lift the cover plate during exhaust port use. A loose-fit between closed cover plates and

exhaust ports also provide leakage areas into the exhaust system. Warped or bent exhaust port frames and cover plates exacerbate the loose fit.
